# Municipality of Swan Valley West

## “Brown Bridge” Rehabilitation

### Quote Request / Tender

➤ **Site 3 – Brown Bridge, over Woody River**

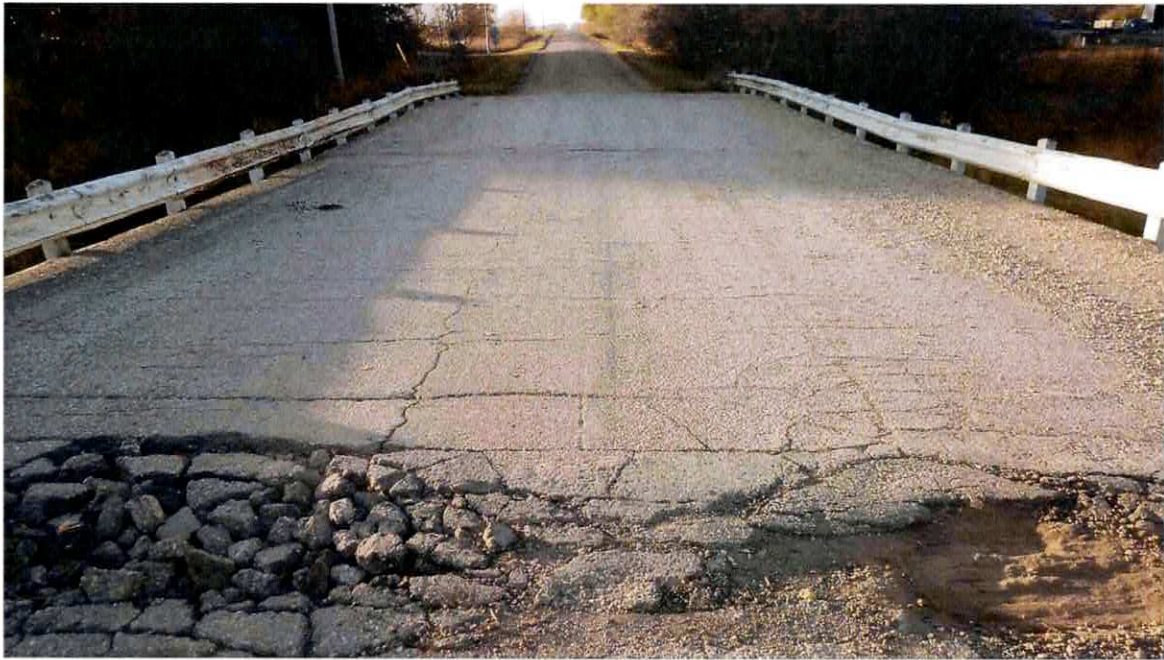
| Location | No. | Element | Material | Unit | Quantity | Condition State | | | Perf. Deficiencies | | | Comments | Recommended Work | Timing (yrs) |
|---|---|---|---|---|---|---|---|---|---|---|---|---|---|---|
| Deck | | Wearing Surface | Asphalt | Sq. m | 257.5 | | | | | | x | (107' long x 25.9' wide) Severe areas of asphalt crumbling and debonding over the SUs due to differential movements and frost heaving of the pile bents. Total poor areas are full width of bridge x 4 feet long and exposing deck boards below. Medium-severe transverse and longitudinal cracking throughout the wearing surface with alligator map cracking stretching from SUs. | Remove existing asphalt and repave following bridge leveling, alternatively patch areas over SUs only. | 1-5 |

Typical wearing surface

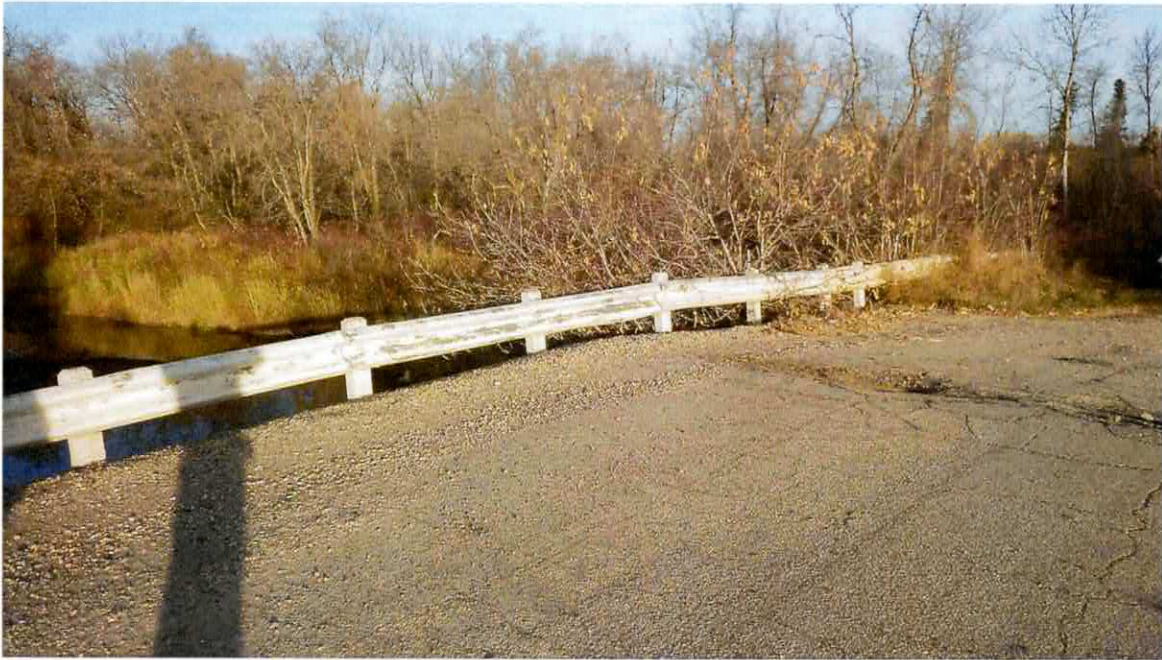
| Location | No. | Element | Material | Unit | Quantity | Condition State | | | Perf. Deficiencies | | | Comments | Recommended Work | Timing (yrs) |
|---|---|---|---|---|---|---|---|---|---|---|---|---|---|---|
| Bridgerail | | Railing | Steel | Ltn. m | 65.2 | x | | | | | x | (12" w-beam) Minor deformations throughout both the East and West Interior (traffic facing) face of W-beam has been painted and has coating failure throughout. Isolated areas of minor corrosion through some coating failures. | | |

Typical railing

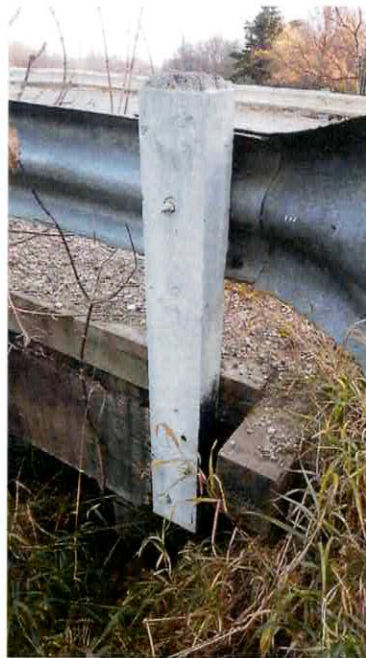
| Location | No. | Element | Material | Unit | Quantity | Condition State | | | Perf. Deficiencies | | | Comments | Recommended Work | Timing (yrs) |
|---|---|---|---|---|---|---|---|---|---|---|---|---|---|---|
| Bridgerail | | Posts | Timber | Each | 36 | | | | | | x | (4"x 6" x 4' long) Posts are painted, majority of posts have some degree of rot. Splits and shrinkage checks typical throughout. Posts and spacers are undersized with insufficient connections for vehicle impact. All girders securing the posts are rotten and have insignificant strength to stop a vehicular collision. | Replace all posts with 8x8 timber posts in conjunction with exterior girder replacements. | 1 |

Typical post

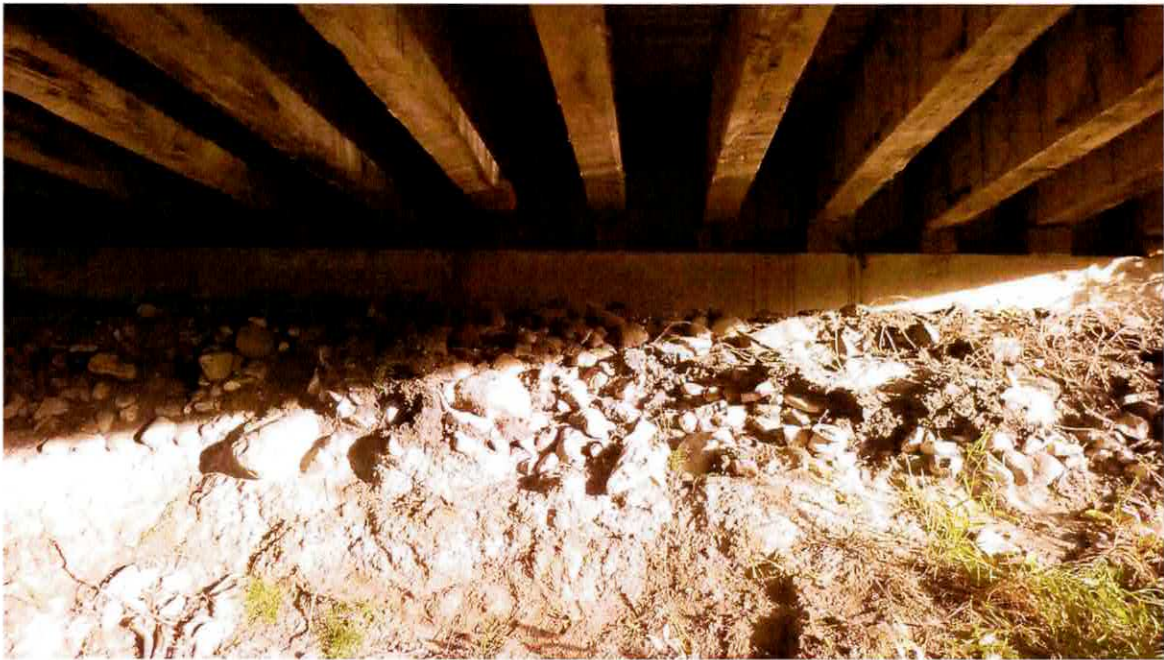
| Location | No. | Element | Material | Unit | Quantity | Condition State | | | Perf. Deficiencies | | | Comments | Recommended Work | Timing (yrs) |
|---|---|---|---|---|---|---|---|---|---|---|---|---|---|---|
| Abutment | SU1 | Backwall | Concrete | Sq. m | 5.3 | x | | | | | | (H = 2) 4"x 6" spacer blocks have been placed under the girders to help level span 1. Concrete is in generally good condition with minor hairline-narrow cracks. | | |

SU1, North abutment

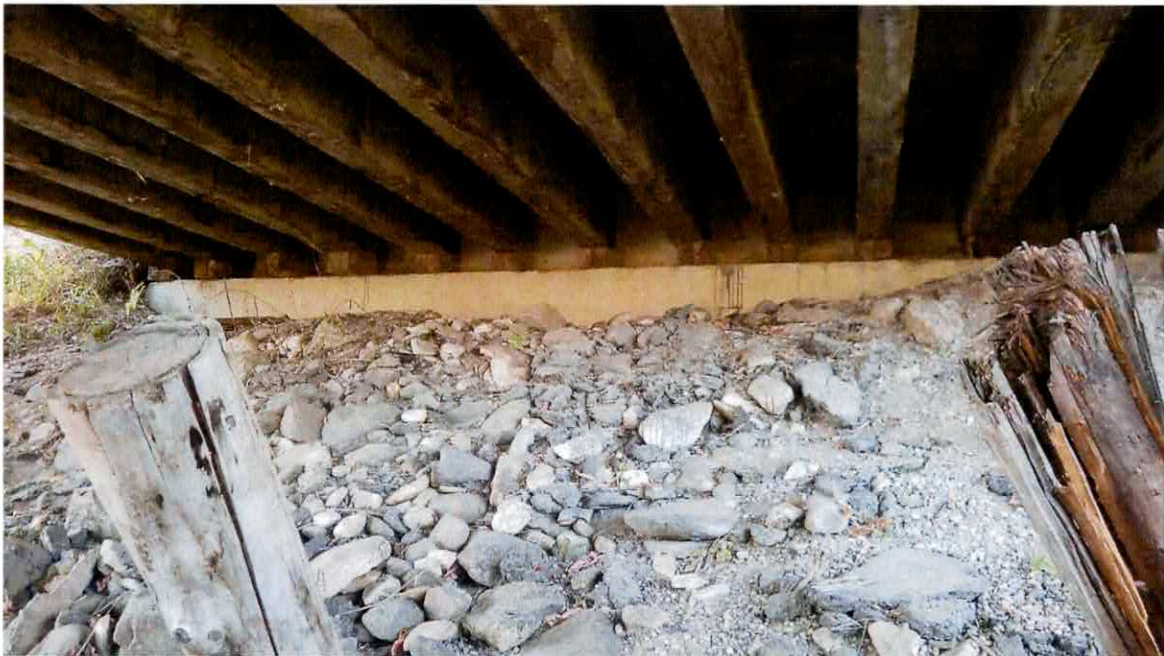
| Location | No. | Element | Material | Unit | Quantity | Condition State | | | Perf. Deficiencies | | | Comments | Recommended Work | Timing (yrs) |
|---|---|---|---|---|---|---|---|---|---|---|---|---|---|---|
| Abutment | SU5 | Backwall | Concrete | Sq. m | 5.3 | x | | | x | | | (H = 27) 4" 6" spacer blocks have been placed under the girders to help level span 4. Concrete is in generally good condition with minor hairline narrow cracks. | | |

SU5, South abutment. NOTE: Spacer blocks under girders

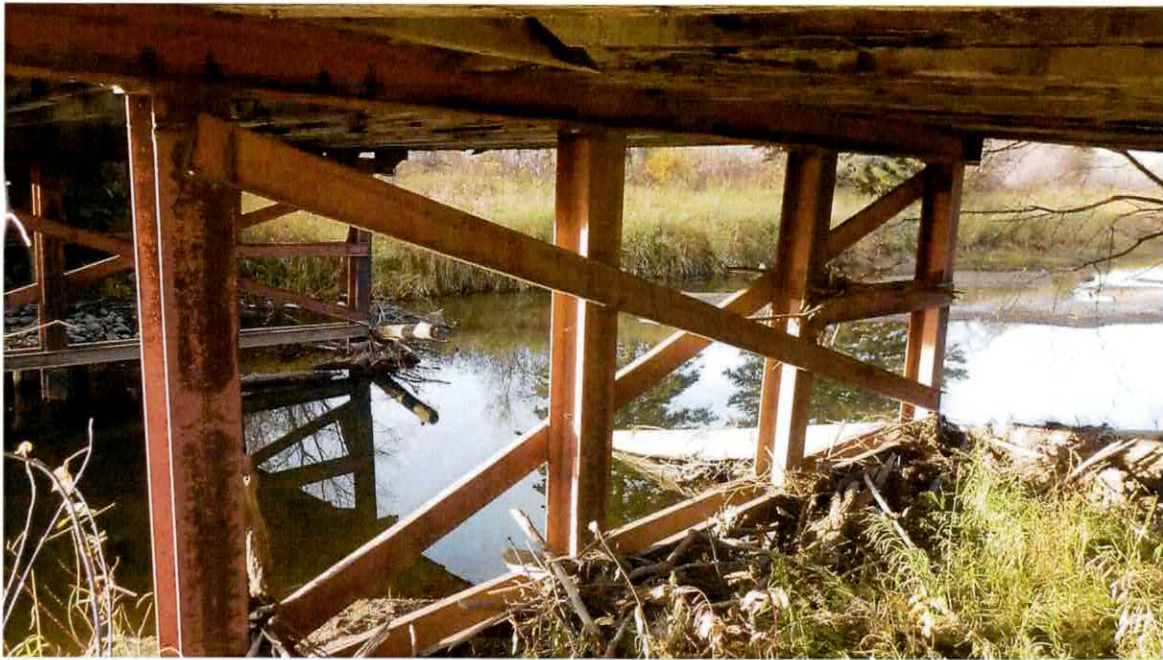
| Location | No. | Element | Material | Unit | Quantity | Condition State | | | Perf. Deficiencies | | | Comments | Recommended Work | Timing (yrs) |
|---|---|---|---|---|---|---|---|---|---|---|---|---|---|---|
| Pier | SU2 | Piles | Steel | Each | 4 | x | | | | x | | (H10 x 42 piles with 8" C-channel bracing) 2x diagonal bracing and 2 x full width horizontal bracing with 1 extra horizontal section of bracing spanning P1-2 on the upstream side. Paint coating is failing throughout with isolated areas of light corrosion. Pile bent appears to be frost heaving creating a significant change in elevation throughout the roadway and a hazard directly above SU2. | Cut piles and level pile bent. Monitor heaving. | 1-5 |

SU2, North elevation

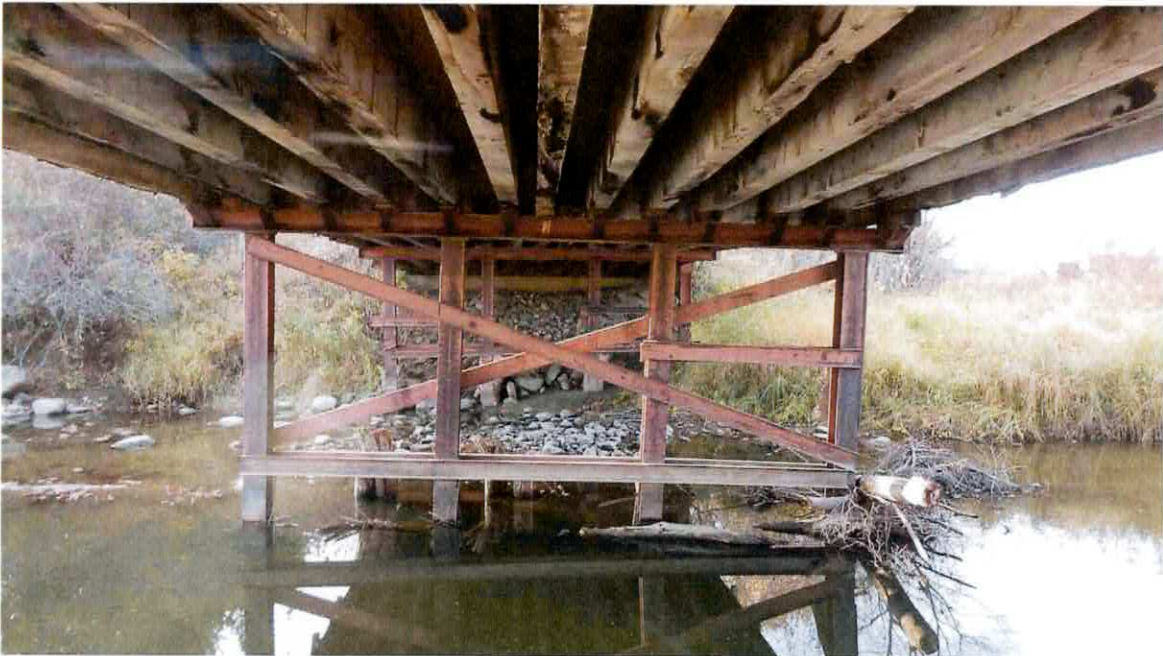
| Location | No. | Element | Material | Unit | Quantity | Condition State | | | Perf. Deficiencies | | | Comments | Recommended Work | Timing (yrs) |
|---|---|---|---|---|---|---|---|---|---|---|---|---|---|---|
| Pier | SU3 | Piles | Steel | Each | 4 | x | | | | x | | (H10 x 42 piles with 8" C-channel bracing) 2x diagonal bracing and 2 x full width horizontal bracing with 1 extra horizontal section of bracing spanning P1-2 on the upstream side. Paint coating is failing throughout with isolated areas of light corrosion. Pile bent appears to be frost heaving with being higher in elevation compared to the abutments although the least compared to SU2 & 4. | Monitor heaving. | |

SU3, North elevation

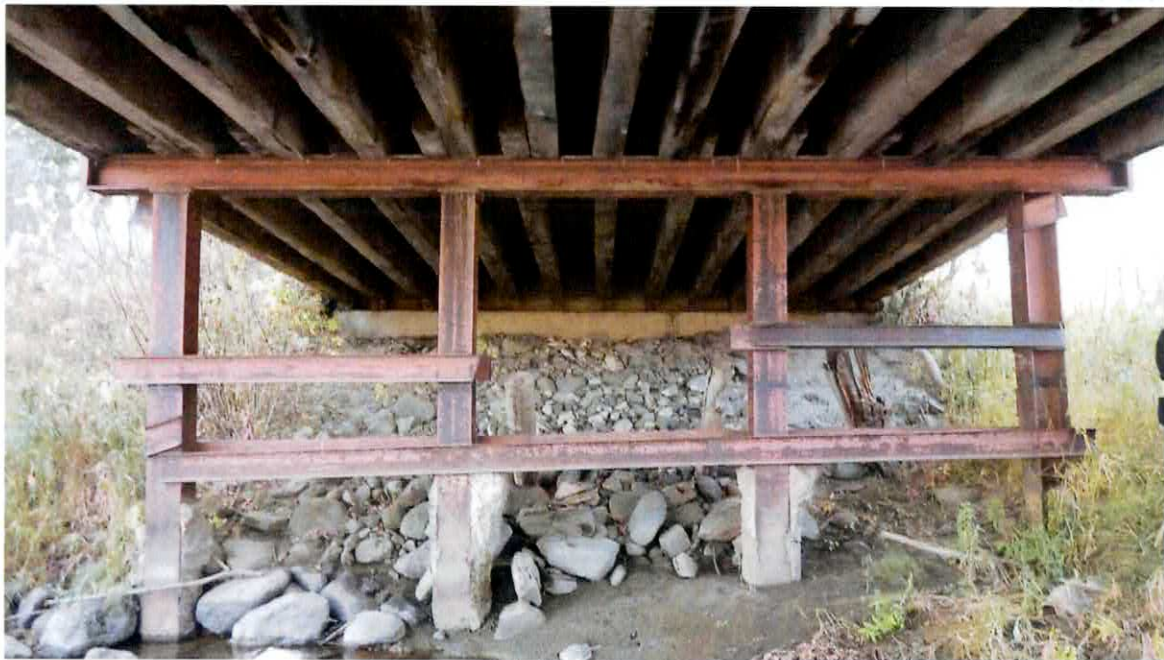
| Location | No. | Element | Material | Unit | Quantity | Condition State | | | Perf. Deficiencies | | | Comments | Recommended Work | Timing (yrs) |
|---|---|---|---|---|---|---|---|---|---|---|---|---|---|---|
| Pier | SU4 | Piles | Steel | Each | 4 | x | | | | | x | (H10 x 42 piles with 8" C-channel bracing) 2 x full width horizontal bracing with extra horizontal section of bracing spanning P1-2 and P3-4. Paint coating is failing throughout with isolated areas of light corrosion. Concrete has been cast around the base of the piles. Exposed length of concrete could indicate some frost heaving action and/or loss of embankment and cover. Concrete around piles can also indicate piles were set into augered holes instead of being driven, likely resulting in insufficient pile depth and subsequent frost heaving. Splice areas above bottom horizontal cross bracing and removed diagonal bracing indicates pile bent could have been previously leveled. Pier is higher in elevation compared to abutments and SU3 due to frost heaving. | Monitor heaving. | |

SU4, North elevation

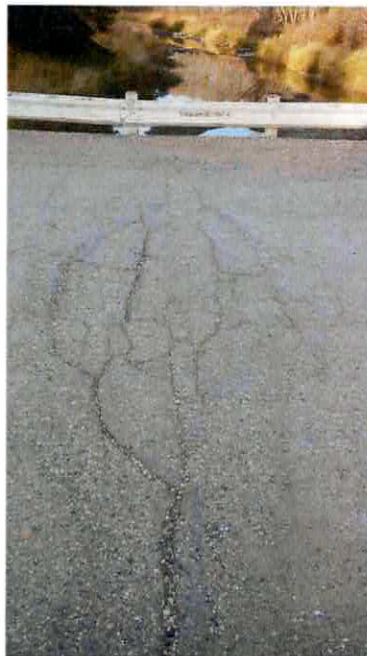
Looking East over SU3. NOTE: Alligator cracking caused by differential movements and pier heaving

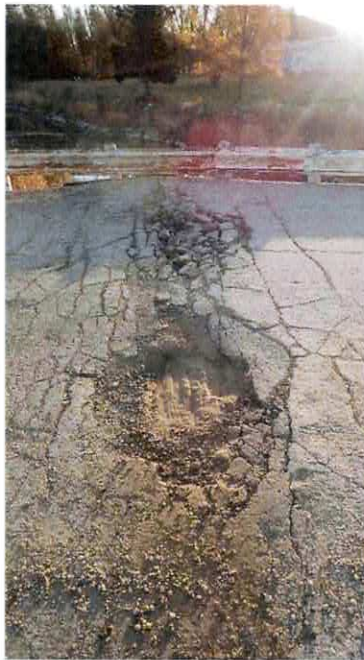
| Location | No. | Element | Material | Unit | Quantity | Condition State | | | Perf. Deficiencies | | | Comments | Recommended Work | Timing (yrs) |
|---|---|---|---|---|---|---|---|---|---|---|---|---|---|---|
| | | Decking | Timber | Sq. m | 257.5 | x | | | x | | | 2x4 boards placed on edge. Exposed boards over the SUs are in overall fair condition. Some boards are in poor condition due to no asphalt protection and the heaving at the SUs causing the boards to bow repeatedly as traffic crosses. Most are still being protected by crumbled asphalt. Remaining of the deck had limited inspection due to asphalt cover. Soffit appears to be in generally good condition. | Replace damaged deck boards in conjunction with deck repaving. | 1-5 |

Looking East over SU2. NOTE: Severe asphalt damage and exposed deck boards

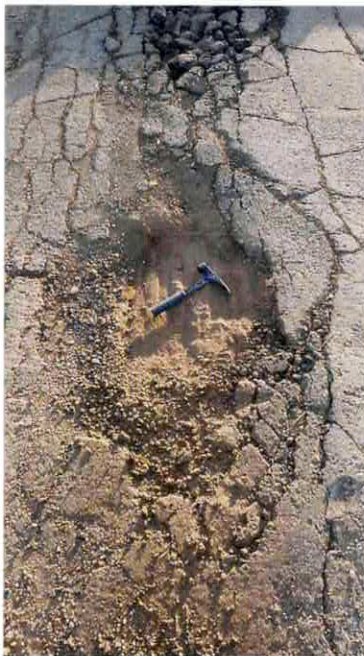
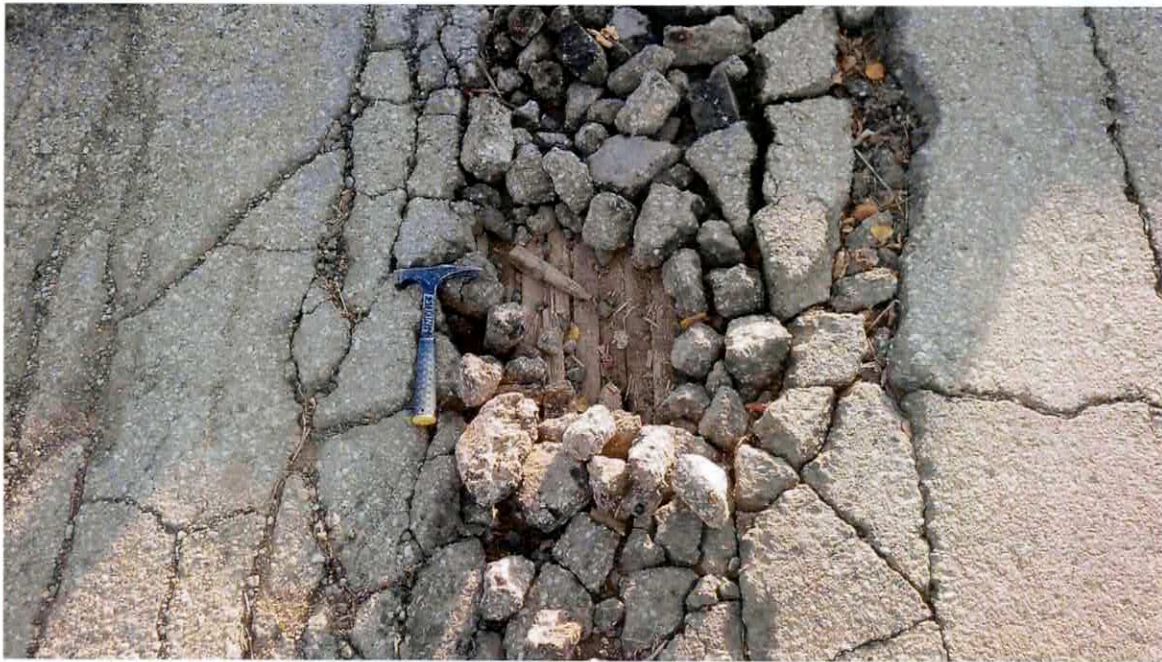
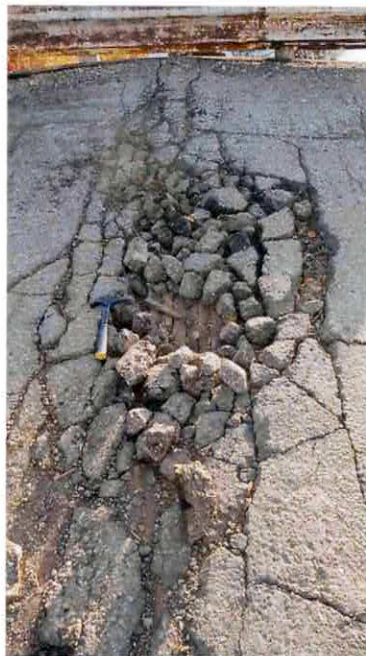
Looking over SU2. NOTE: Missing asphalt with exposed deck boards (1)

Looking over SU2. NOTE: Missing asphalt with exposed deck boards (2)

Looking over SU2. NOTE: Missing asphalt with exposed deck boards (3)

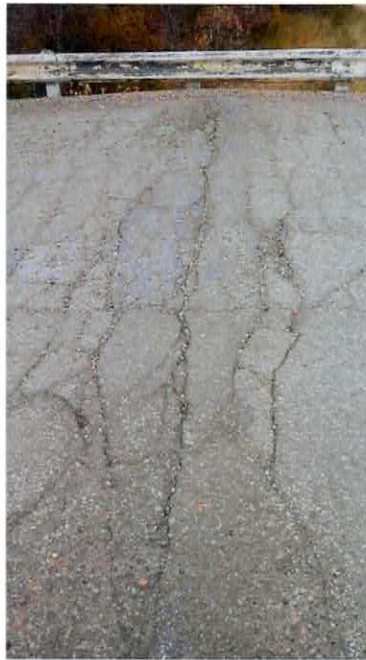
Looking East over SU4. NOTE: Alligator cracking caused by differential movements and pier heaving

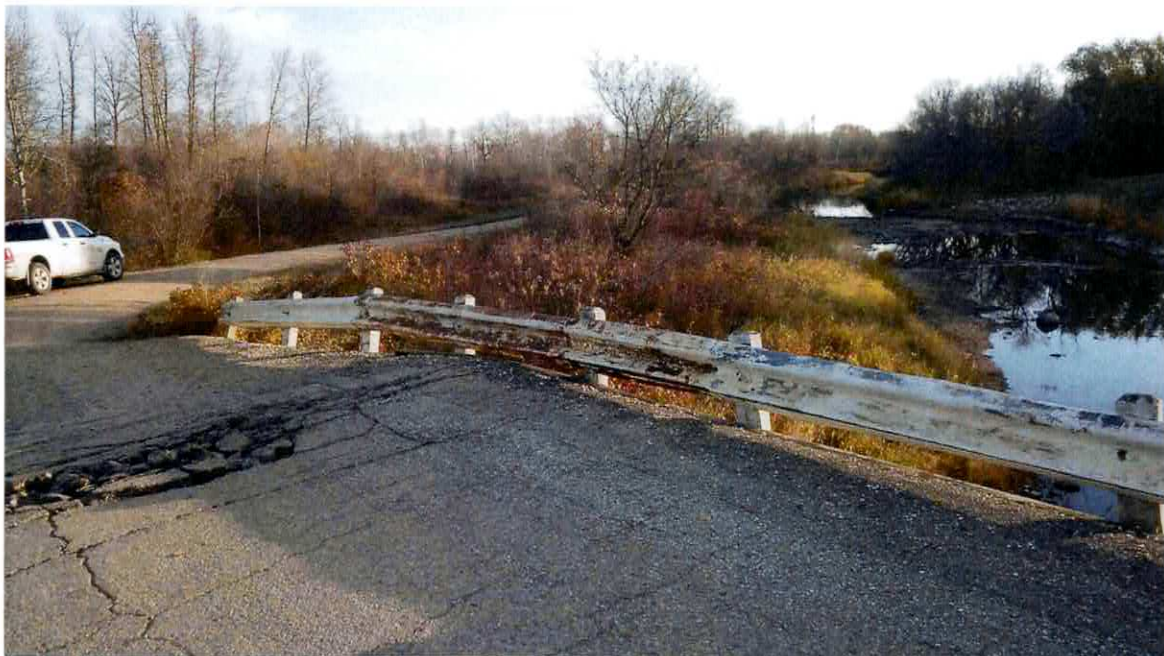
Showing heaving at SU2, East side

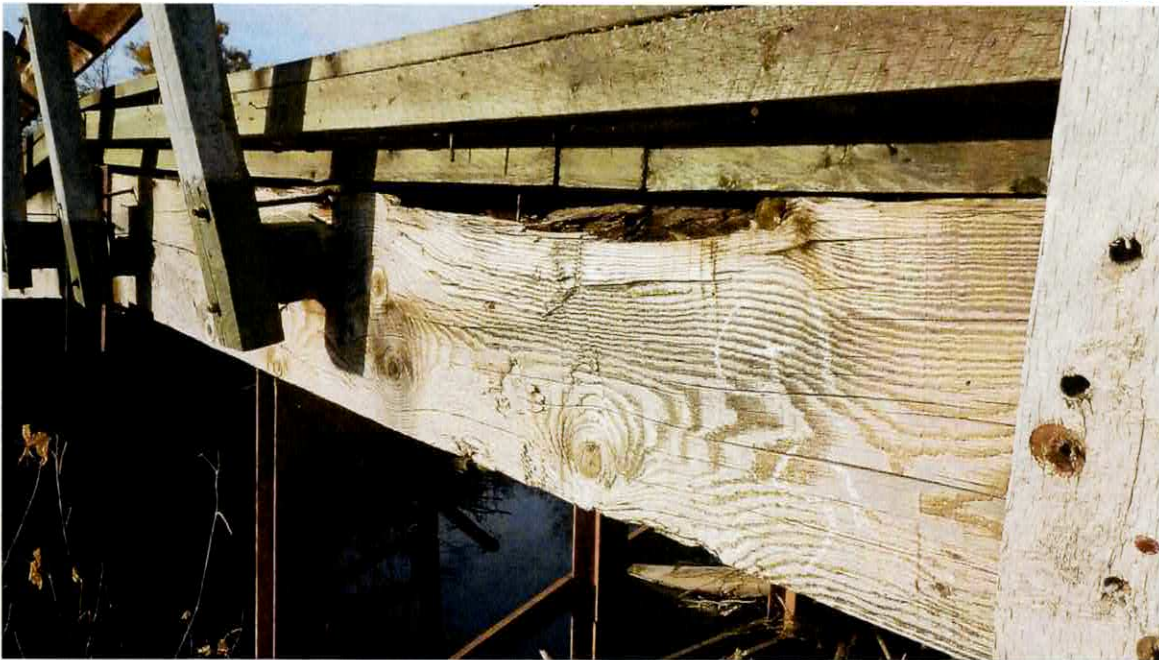
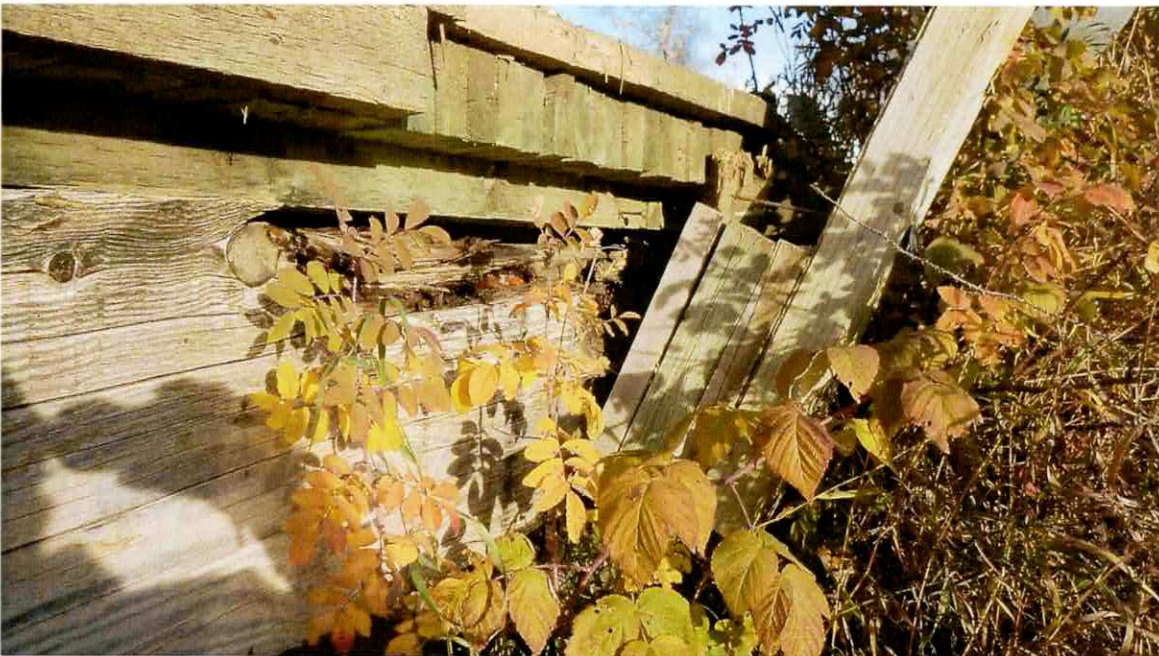
| Location | No. | Element | Material | Unit | Quantity | Condition State | | | Perf. Deficiencies | | | Comments | Recommended Work | Timing (yrs) |
|---|---|---|---|---|---|---|---|---|---|---|---|---|---|---|
| Span | 1 | Stringers | Timber | Each | 13 | | | | | | x | (8"x 12") G1: top 13" rotten; G3: bottom 4" rotten, bottom half replaced at SU2; G6: top half replaced with 3x16s and split at notch at SU2; G7: top 4" rotten, G10: up to 3" section loss; G11: top 6" rotten, crack at bottom & side; G12: top 3" rotten, G13: top 6" rotten | Replace exterior stringers G1 & G13, sister in stringers beside G3, 5, 6, 7, 10, 11 & 12. Alternatively, replace superstructure. | 1-5 |

G1, span 1. NOTE: Severe rot throughout (1)

G1, span 1. NOTE: Severe rot throughout (2)

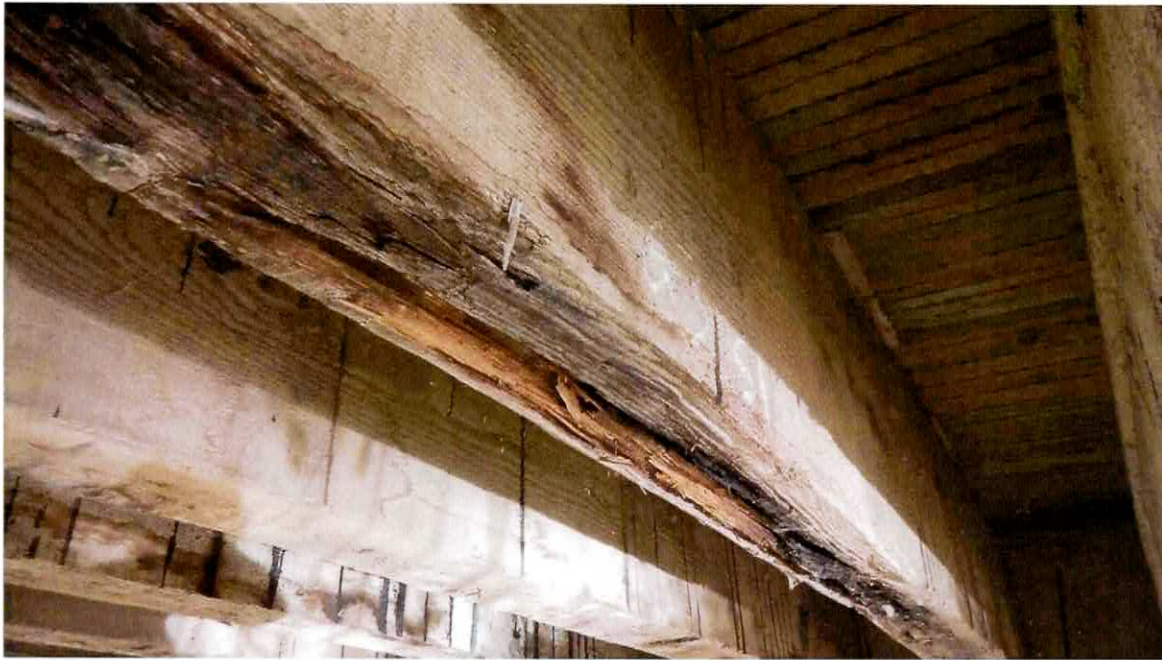
G5, span 1. NOTE: Severe rot along underside

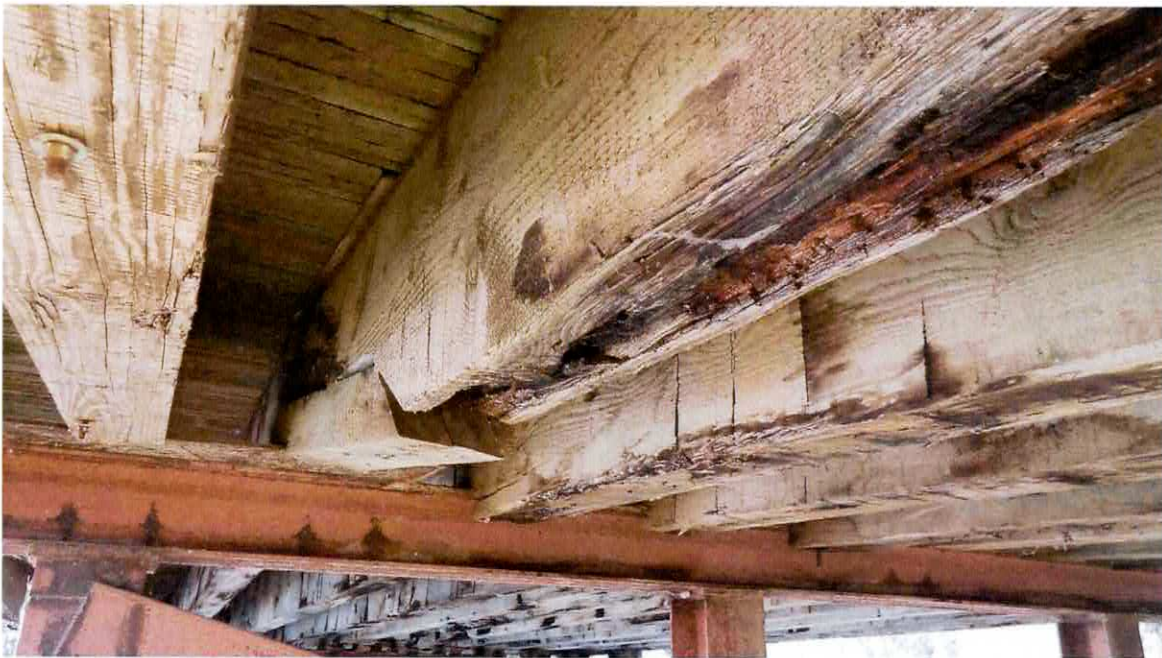
G5, span 1. NOTE: Rotten along under side and splintered at SU2.

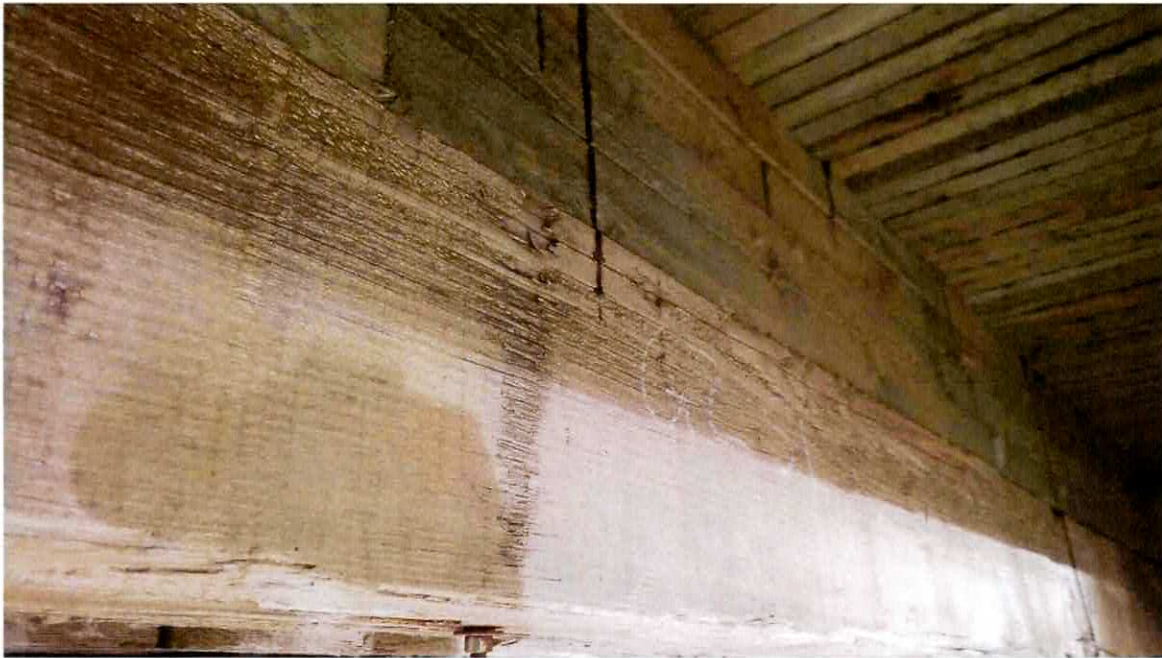
G6, span 1. NOTE: Girder is only half height and top half is constructed of other timbers

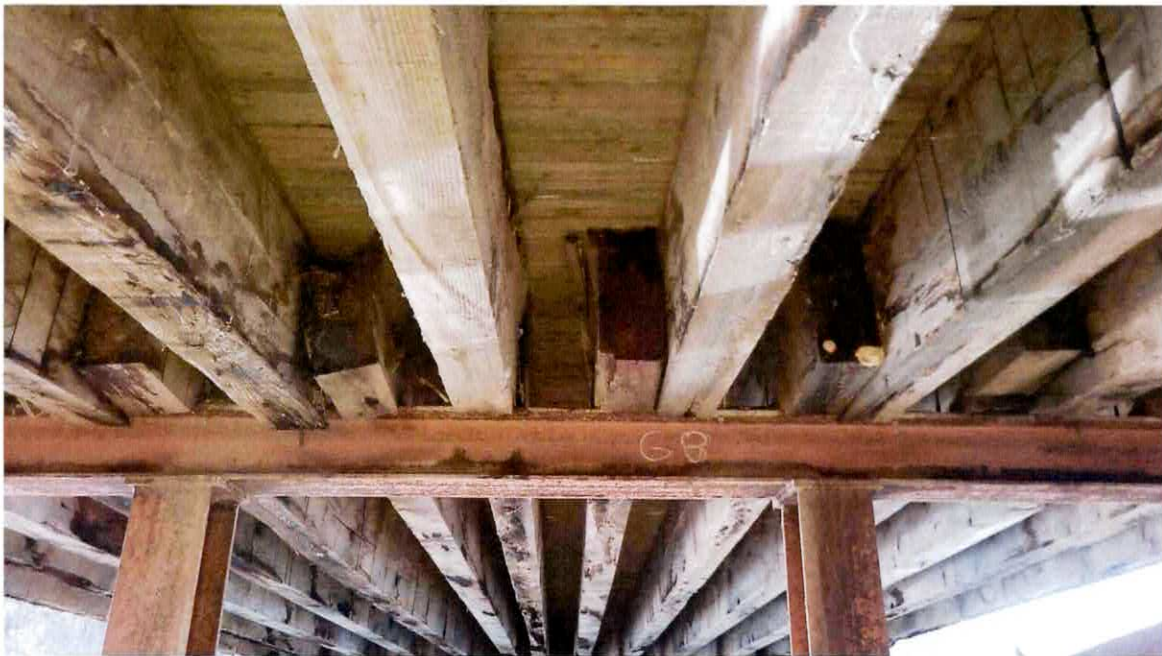
| Location | No. | Element | Material | Unit | Quantity | Condition State | | | Perf. Deficiencies | | | Comments | Recommended Work | Timing (yrs) |
|---|---|---|---|---|---|---|---|---|---|---|---|---|---|---|
| Span | 2 | Stringers | Timber | Each | 13 | | | x | | | x | (8"x 12") G1, G2, G6, G7, G8, G13 rotten at SU2; G7: bottom half cut out and replaced at SU3. | Replace exterior stringers G1 & G13, sister in stringers beside G2, G6, 7 & 8. Alternatively, replace superstructure. | 1-5 |

G6 and G8, span 2. NOTE: Rotten and crushing along top face.

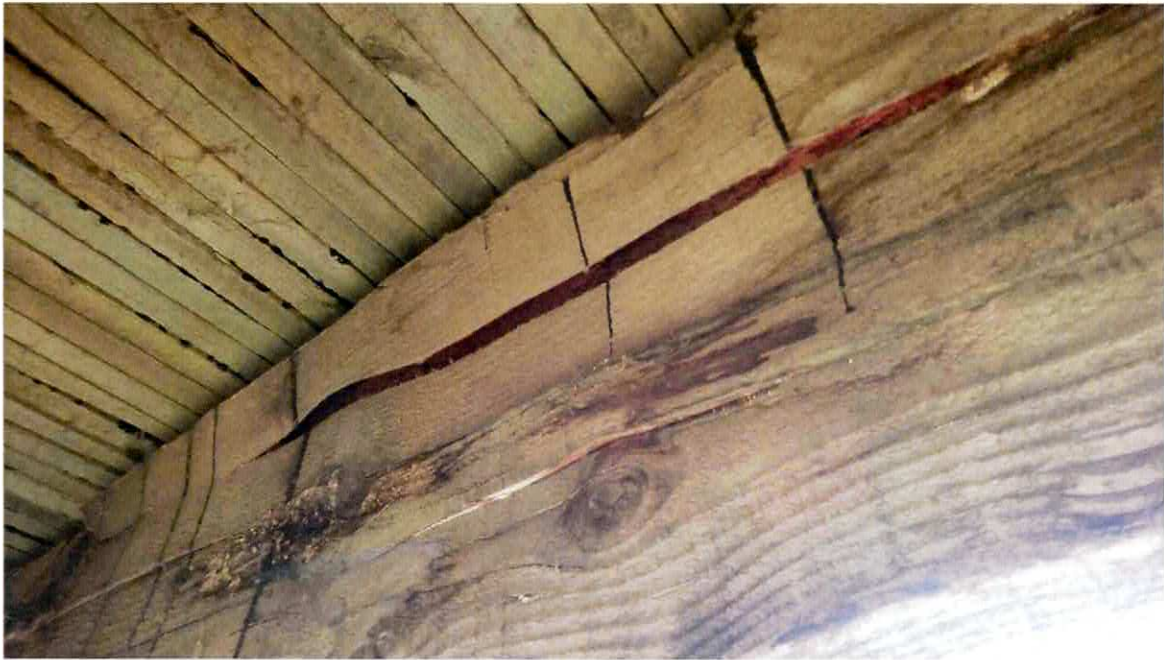
G13, span 1. NOTE: Severe rot

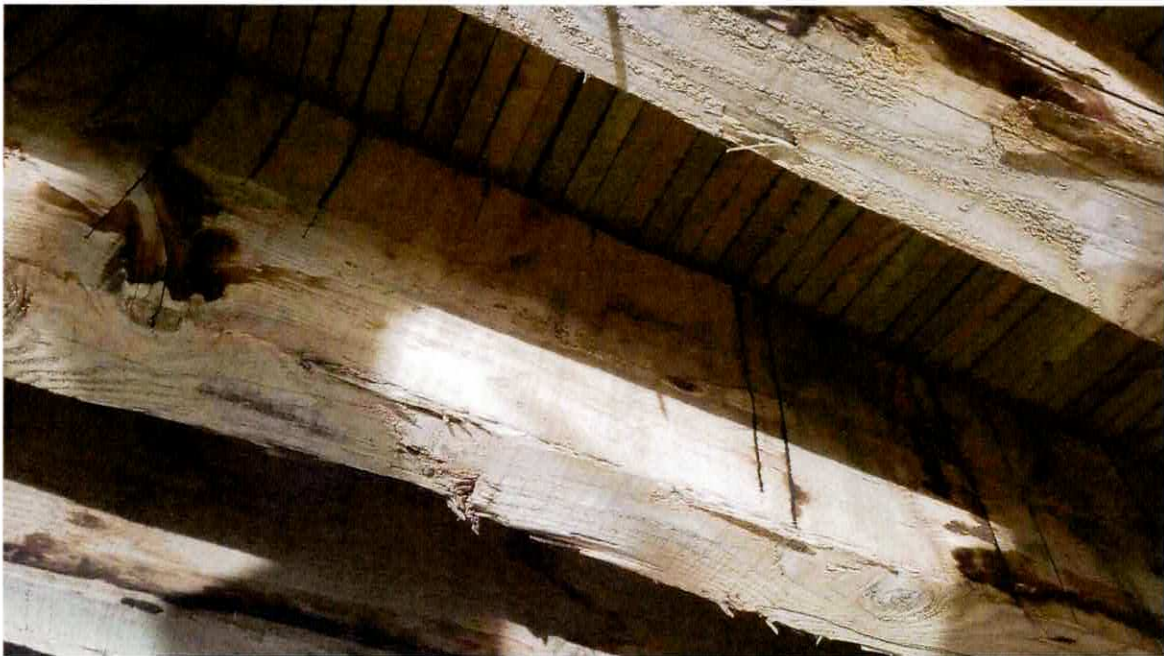
Span 2 minor girder defects

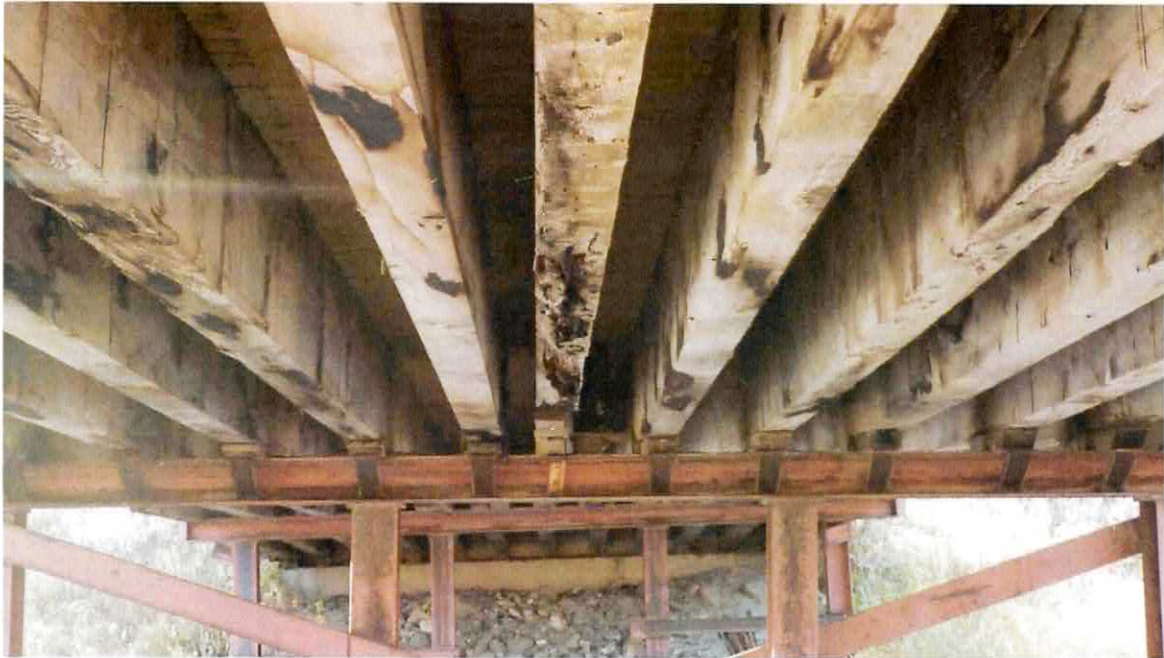
G7 span 2, NOTE: Rot along underside of G7

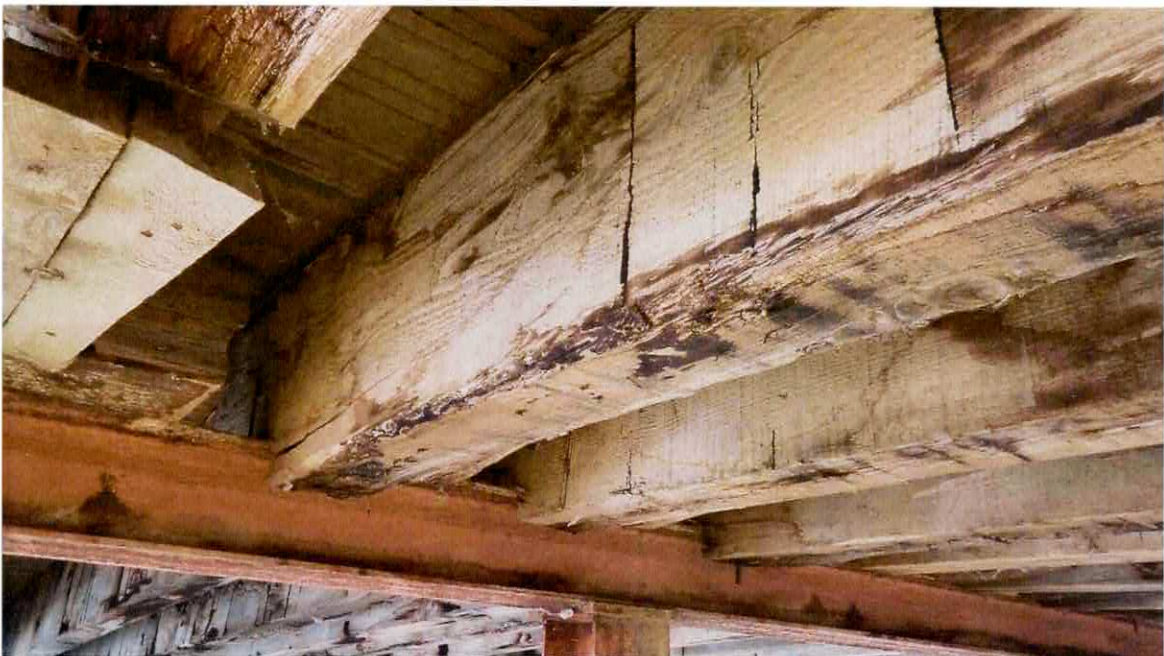
G6 span 1, NOTE: Splitting at end notch

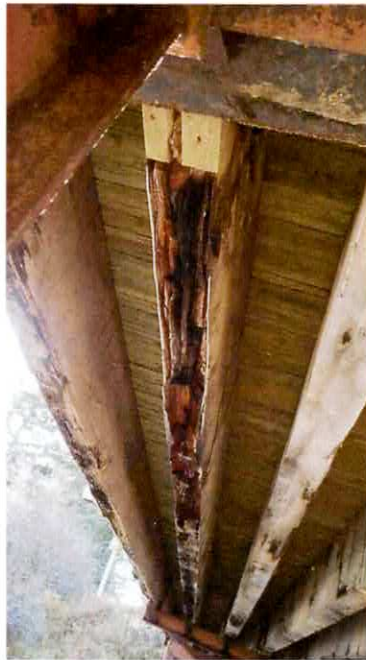
G2, span 2. NOTE: Rotten along underside

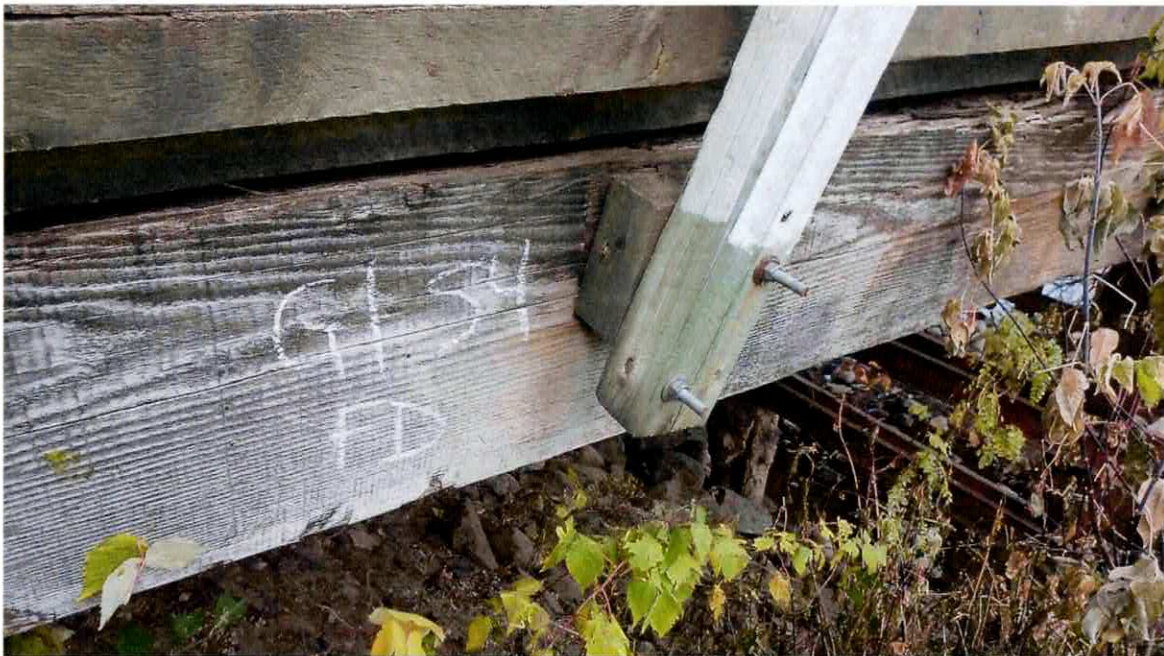
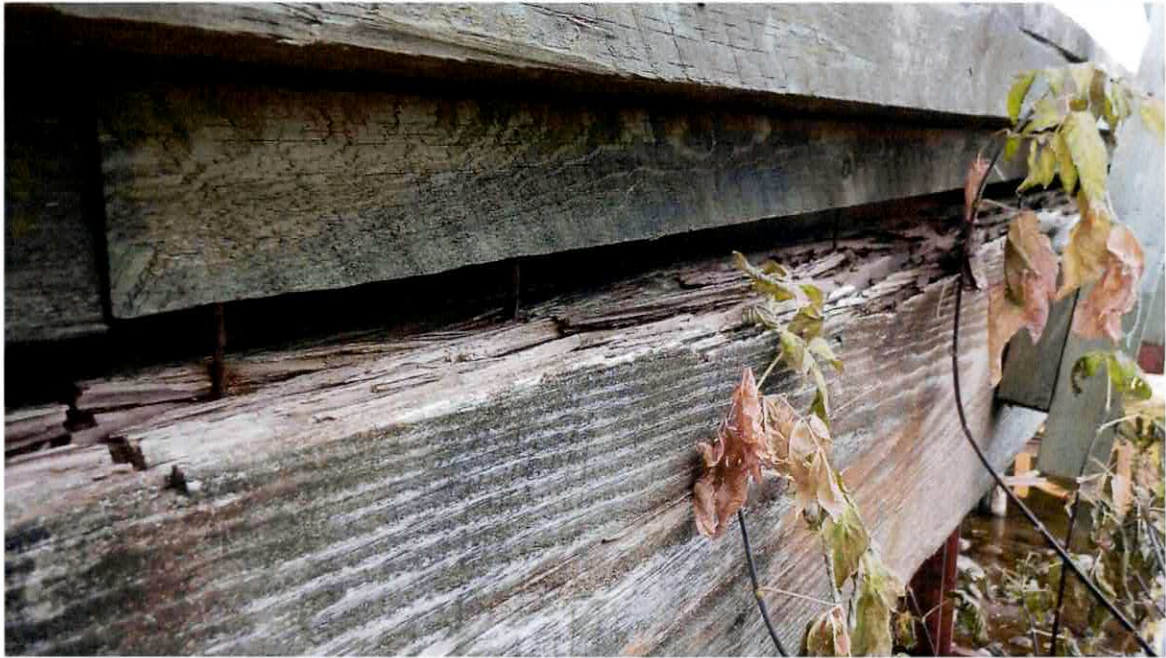
| Location | No. | Element | Material | Unit | Quantity | Condition State | | | Perf. Deficiencies | | | Comments | Recommended Work | Timing (yrs) |
|---|---|---|---|---|---|---|---|---|---|---|---|---|---|---|
| Span | 4 | Stringers | Timber | Each | 13 | | | x | | | x | (8"x 12") G1: top 10" rotten near SU3, fully rotten at SU4; G2: top 2" rotten near SU3; G11: top 4" rotten at SU4; G12: top 4" rotten near SU3; G13: top 5" rotten near SU3 | Replace exterior stringers G1 & G13, sister in stringers beside G2, 11 & 12. Alternatively, replace superstructure. | 1-5 |

G1, span 4. NOTE: Rotten, full depth (1)

G1, span 4. NOTE: Rotten, full depth (2)

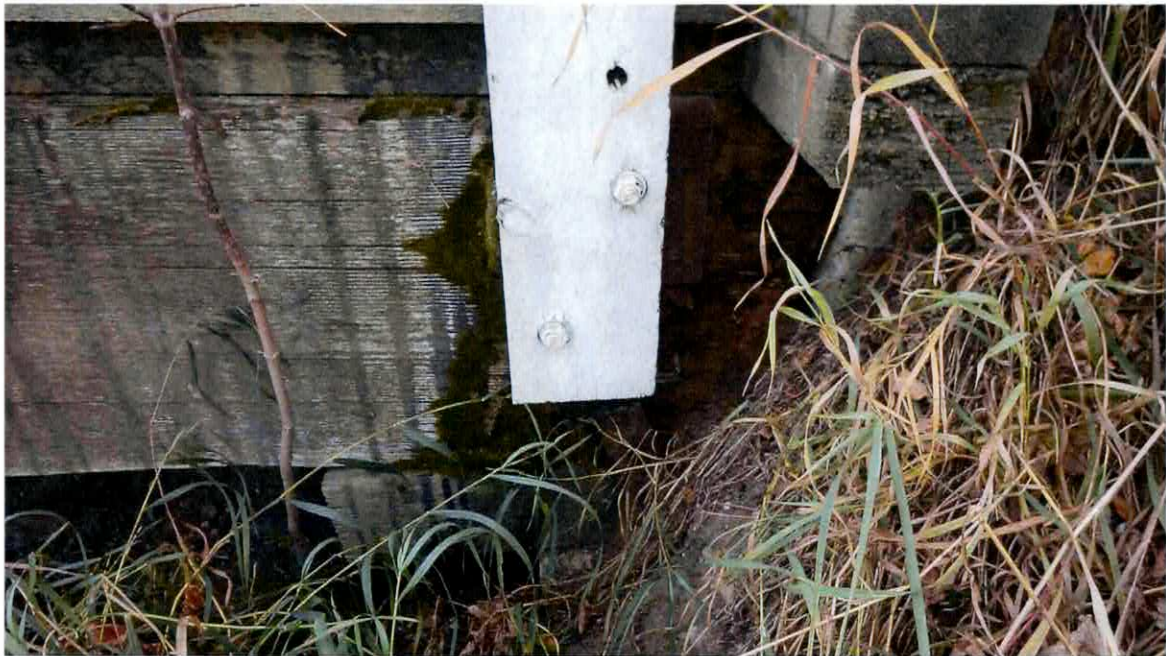
G13, span 4. NOTE: Severe rot over abutment

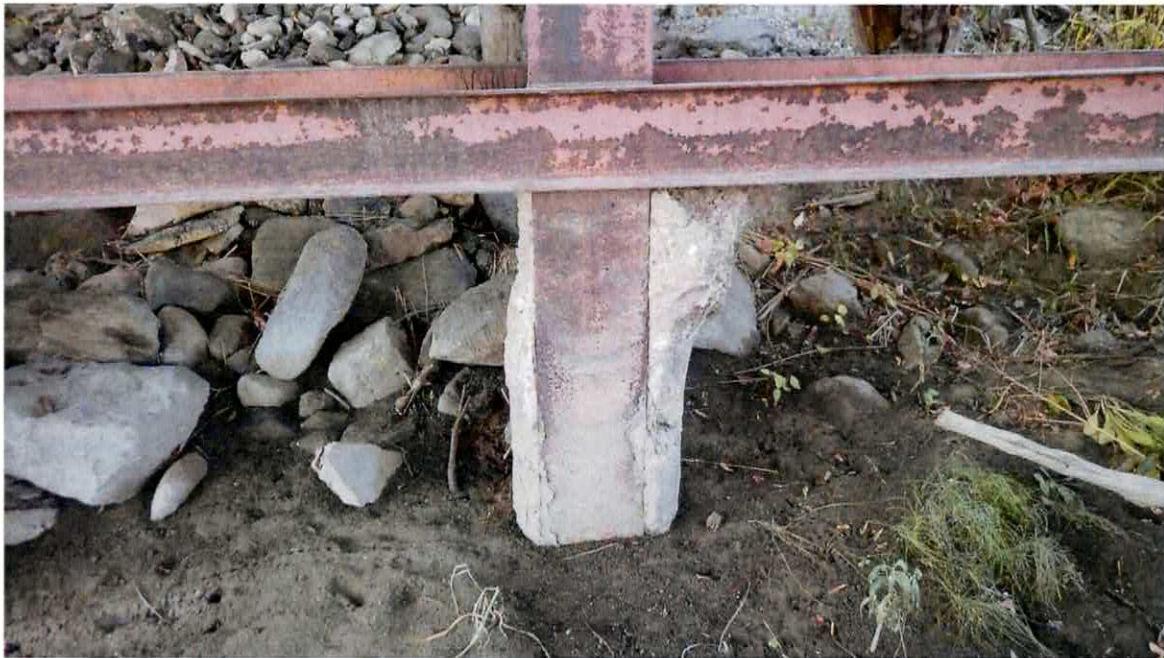
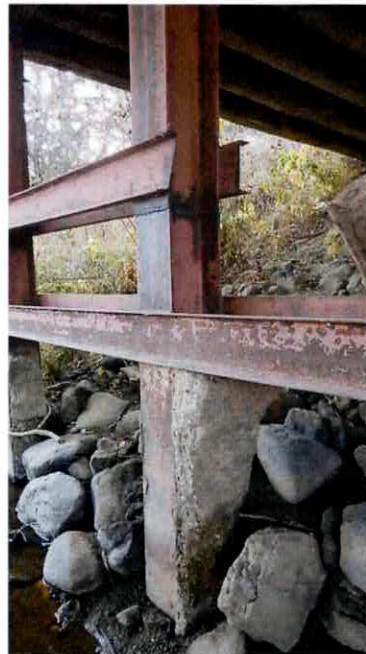
SU4 pile at groundline. NOTE: Concrete has been cast around the pile bases. (1)

SU4 pile at groundline. NOTE: Concrete has been cast around the pile bases. (2)
